TECHNICAL NOTE 3512

EFFECT OF SOME SELECTED HEAT TREATMENTS ON THE
OPERATING LIFE OF CAST HS-21 TURBINE BLADES

By Francis J. Clauss, Floyd B. Garrett, and
John W. Weeton

Lewis Flight Propulsion Laboratory
Cleveland, Ohio

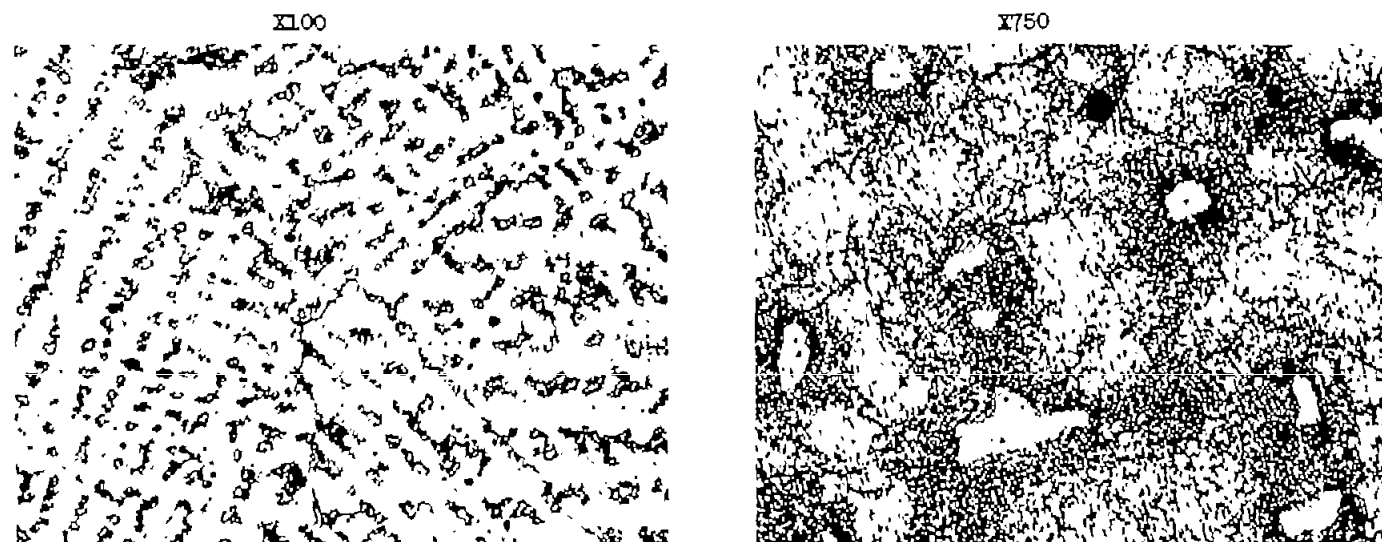
Figure 26. - Microstructure of cast BS-21 turbine blade solution treated 24 hours at 2050° F, air cooled, and aged 48 hours at 1200° F after operation 68.4 hours at rated speed (group 12). Electrolytically etched in 5 percent aqua regia.

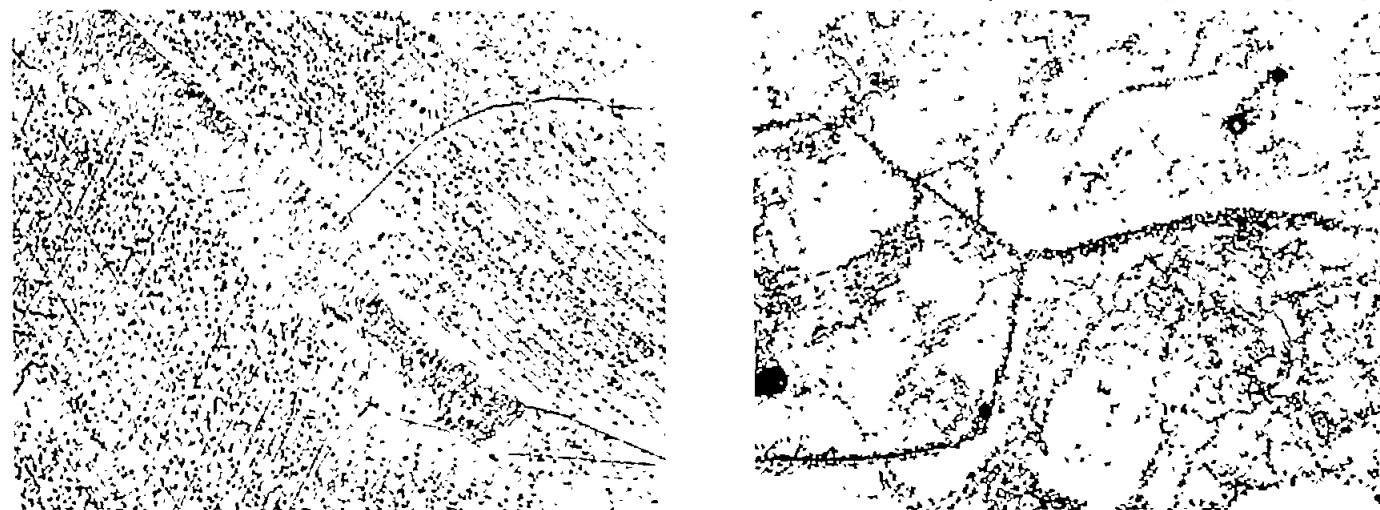
Figure 27. - Microstructure of cast BS-21 turbine blade solution treated 24 hours at 2175° F, air cooled, and aged 48 hours at 1200° F after operation 64.1 hours at rated speed (group 14). Electrolytically etched in 5 percent aqua regia.

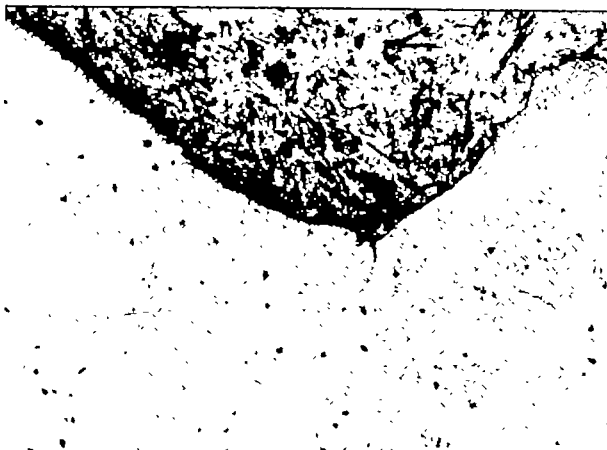
Figure 28. - Fracture of blade from group 14. Electrolytically etched in 5 percent aqua regia.

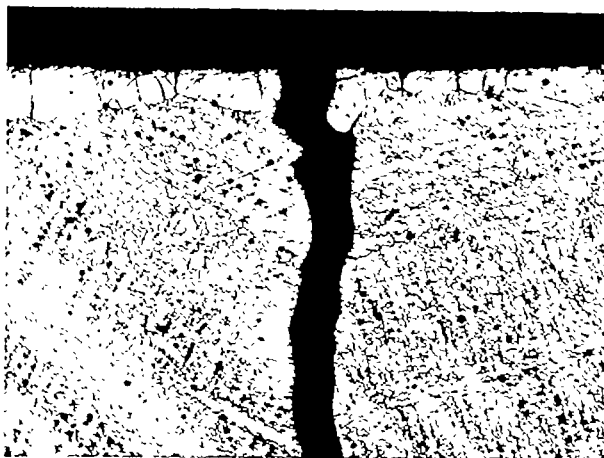
Figure 30. - Crack below fractured edge of blade from group 13. Electrolytically etched in 5 percent aqua regia.

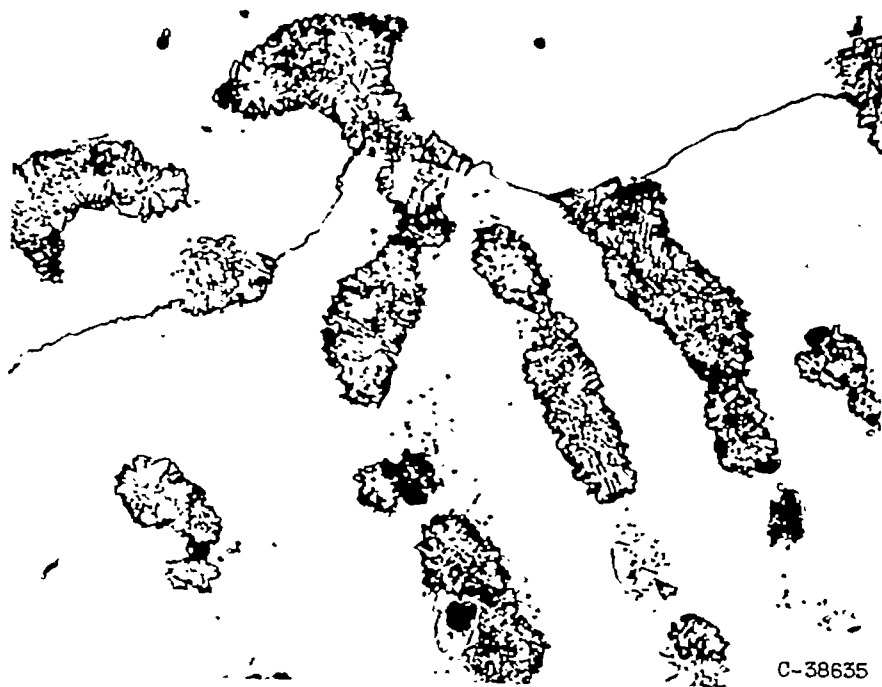
Figure 31. - Microstructure of as-cast specimens cut from small turbosupercharger blades. Electrolytically etched in 5 percent aqua regia.

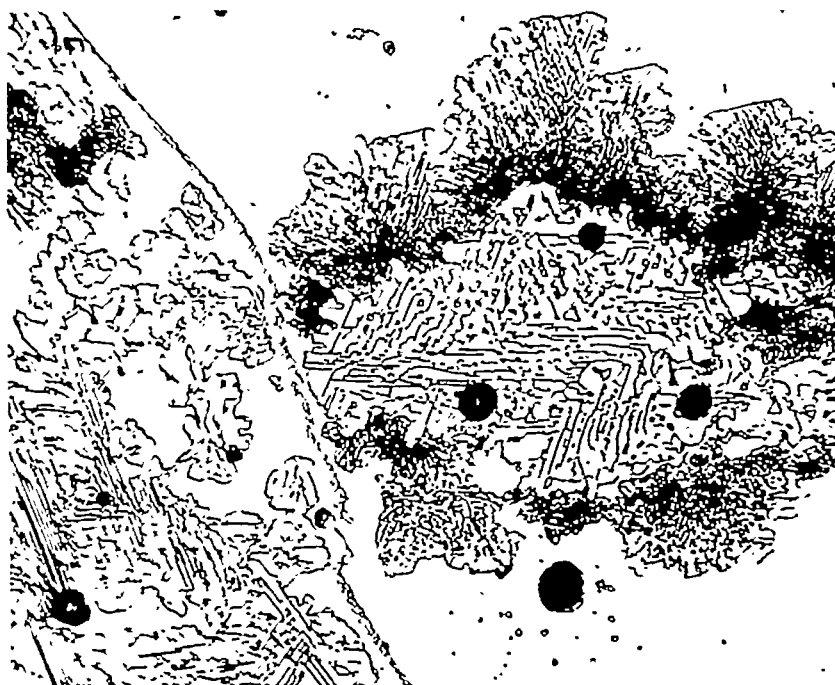
Figure 32. - Microstructure of specimens cut from small turbosupercharger blades given heat treatment of reference 3 (1 hr at 2150° F, furnace cooled to 1800° F in 6 hr, air cooled, and aged 72 hr at 1500° F). Electrolytically etched in 5 percent aqua regia.
